**TOWN OF NEWBURGH
PLANNING BOARD
TECHNICAL REVIEW COMMENTS**

PROJECT NAME: SCANNELL-NEWBURGH COMMERCE CENTER
PROJECT NO.: 2021-21
PROJECT LOCATION: SECTION 95, BLOCK 1, LOT 58
REVIEW DATE: 11 MARCH 2022
MEETING DATE: 17 MARCH 2022
PROJECT REPRESENTATIVE: LANGAN ENGINEERING

TOWN OF NEWBURGH
ORANGE COUNTY, NEW YORK
SECTION 95, BLOCK 1, LOT 58
PLANNING BOARD PROJECT No: 2021-21

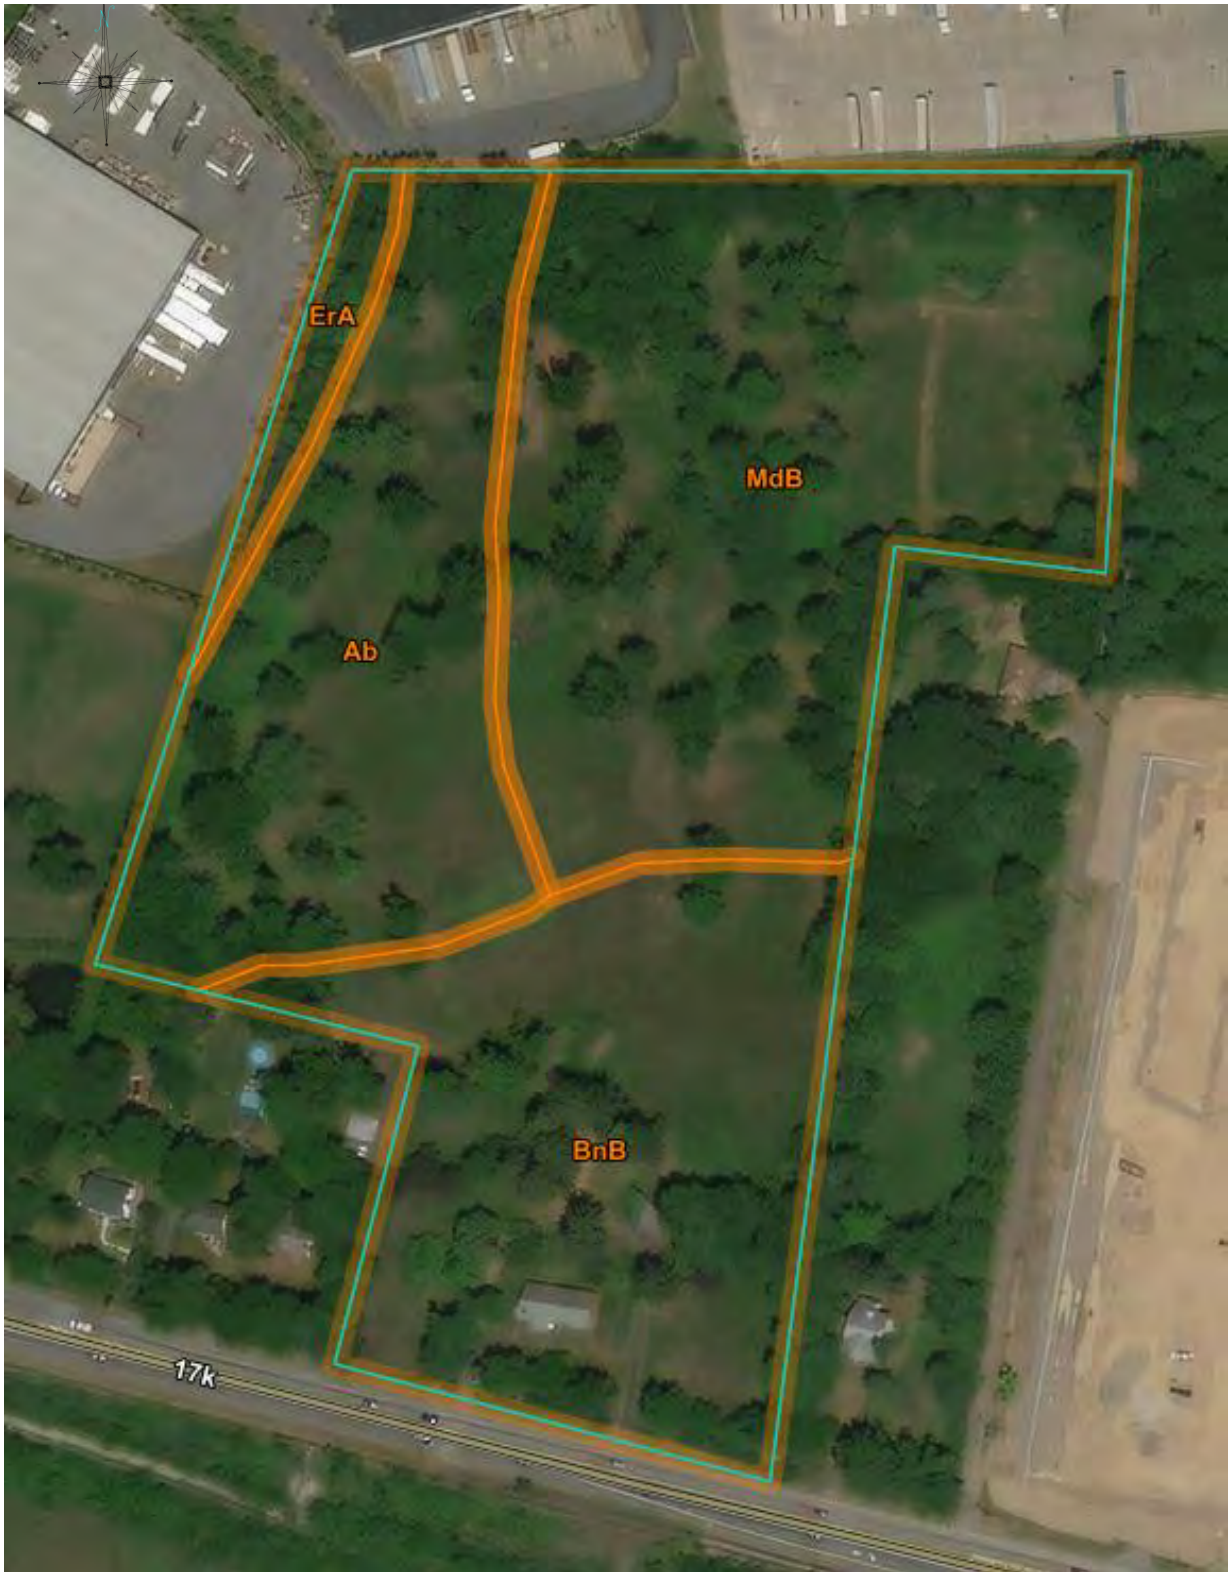
Figure 3: Aerial Image showing the soil classifications within the Project APE. (Source: Natural Resource Conservation Service). Scale: 1" =165'.

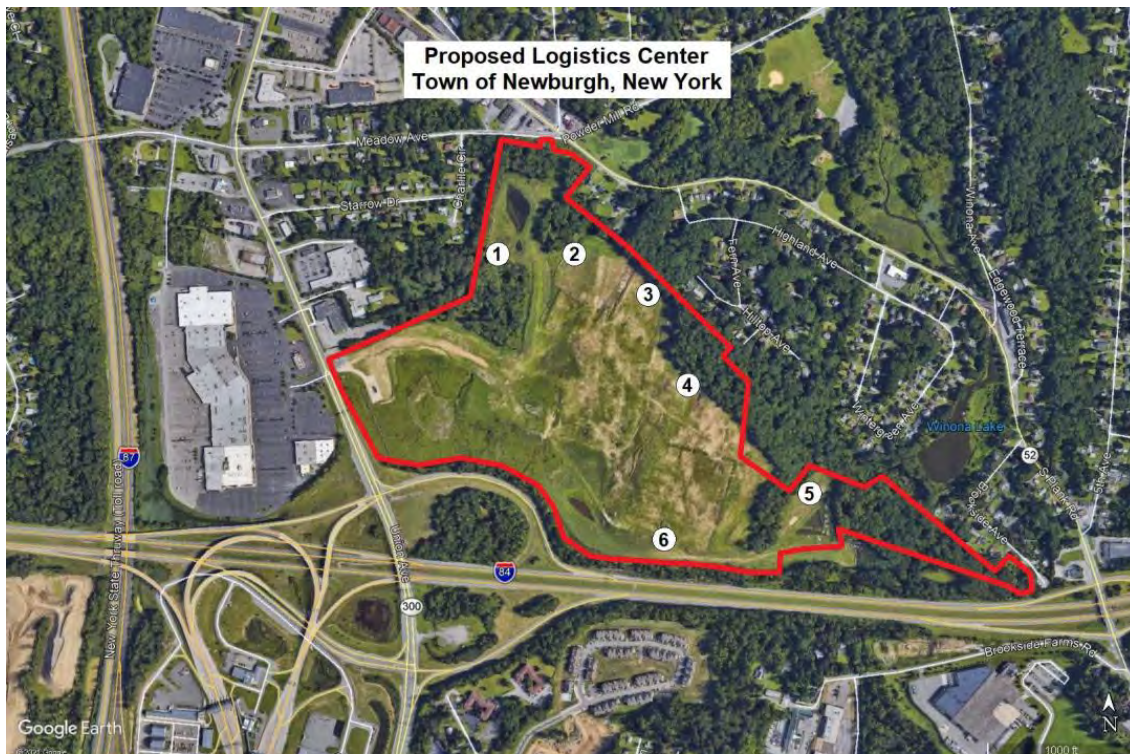
Figure 1 — Google Earth image showing the proposed logistics center site and vicinity in the Town of Newburgh, NY. The site property line is approximately outlined in red. Ambient sound survey Locations also shown.
